# *Maffei Property Inspections*

## Property Inspection Report

354 Your Home Way, Chico CA, 95973  
Inspection prepared for: Inspection Sample & Inspection Sample  
Inspection Date: 3/4/2012 Time: 12:30pm  
Age: Approx. 20 Size: 3000 sq ft  
Weather: Sun no rain in last 3 days  
For this report the front of the home, the front door face East.

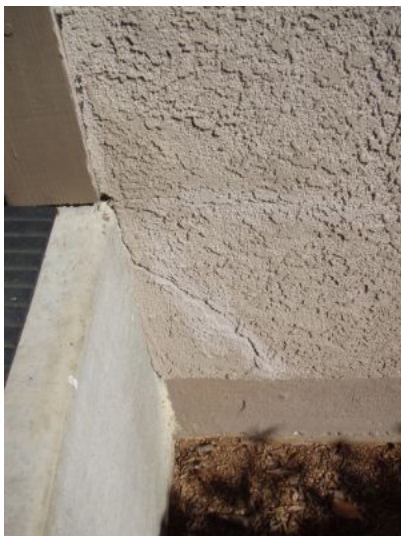
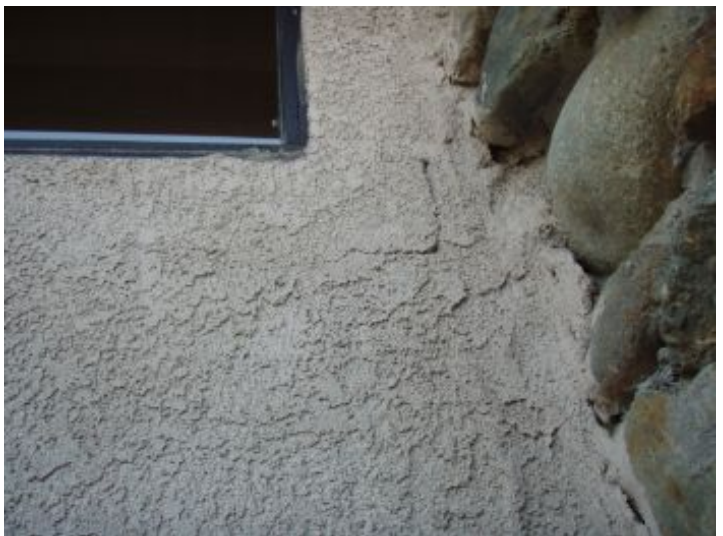
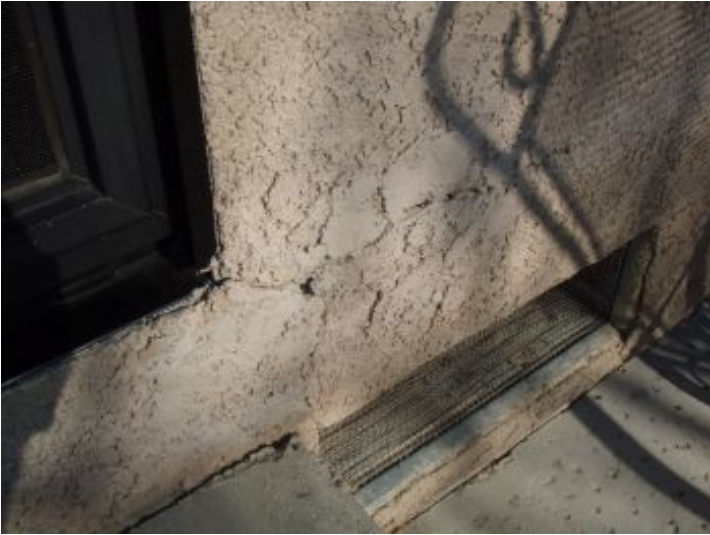
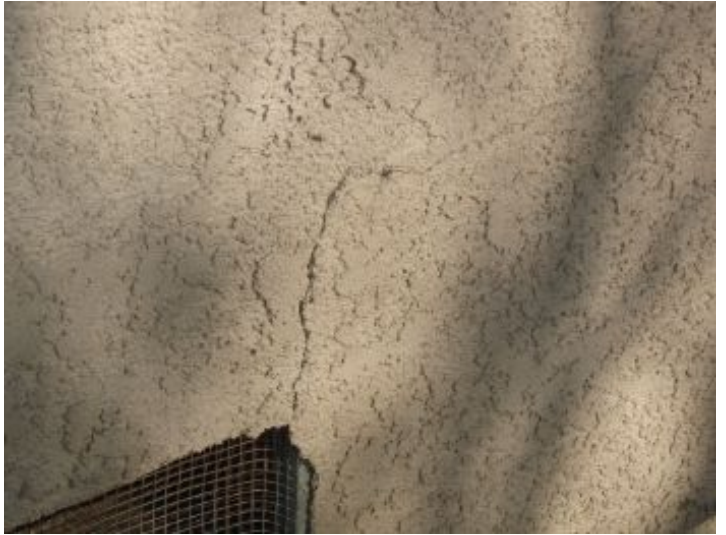
- There is stucco missing in areas of the exterior. We recommend having a qualified contractor evaluate and repair the areas.

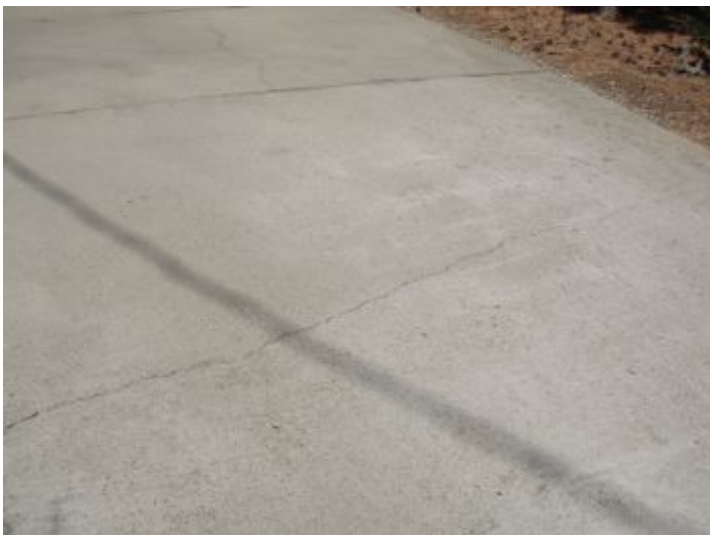
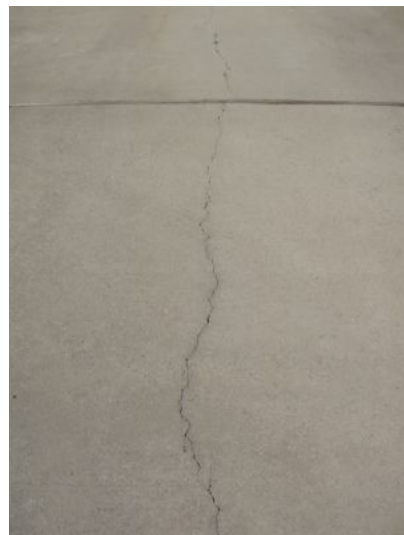
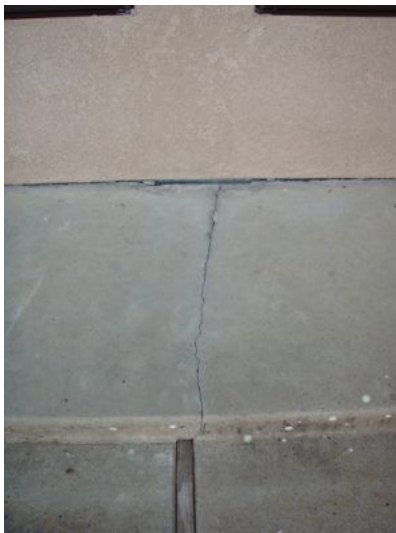
- Driveway in good shape for age and wear. Some oil staining. Clean and seal to extend life.
- IMPROVE: Typical cracking was observed at the concrete surfaces. Further deterioration will occur as water expands and contracts from freeze and thaw cycles. Recommend sealing the cracks to prolong the life of the concrete.
- Gravel driveways need ongoing maintenance. Repair as needed.
- Moderate cracks in sidewalk. Repair and / or monitor for expansion and development of trip hazards.

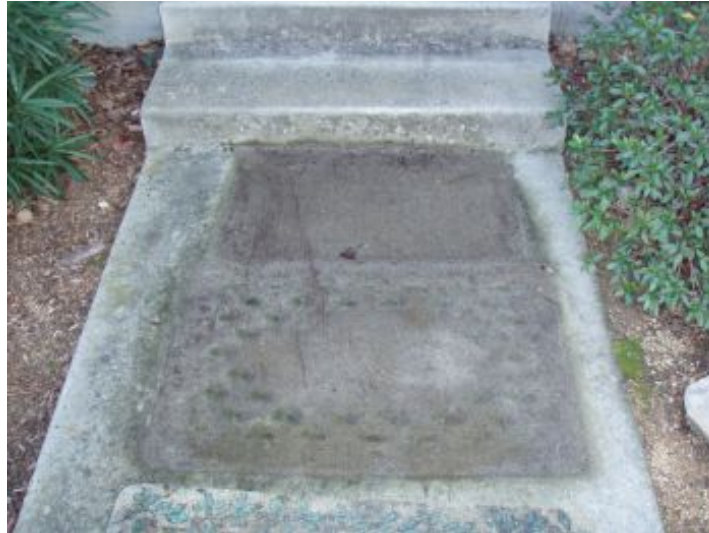
- There were no railings installed at the steps. Location: .
- Stairs at front door are in shade. A mold like growth was noted. If unchecked this growth could pose a slipping hazard.

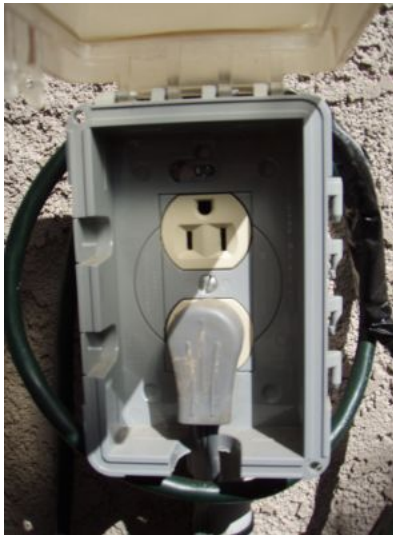
- Outlet damaged or apparently inoperable.
- Overhead electrical service clearance - Service conductors have inadequate height clearance from the ground. Requirements are as follows: 10 feet above a walkway (including decks and balconies), 12 feet above a drive, 18 feet above a roadway and 3 feet from an openable window. Contact local public service company to inquire about correction.
- Hot ground: exterior outlet near valves for sprinklers has a hot neutral. Recommend checking with a license electrician.

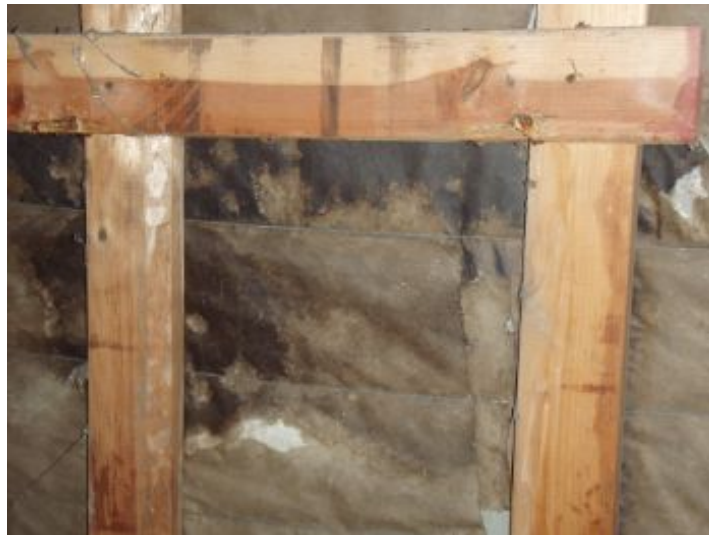
- Could not access all areas of the attic due to limited space.
- Evidence of leaking along wall with southern exposure. Recommend review by a qualified professional for repair or replacement, as necessary, prior to close.

Moister appears to have penetrated the exterior wall at some point.

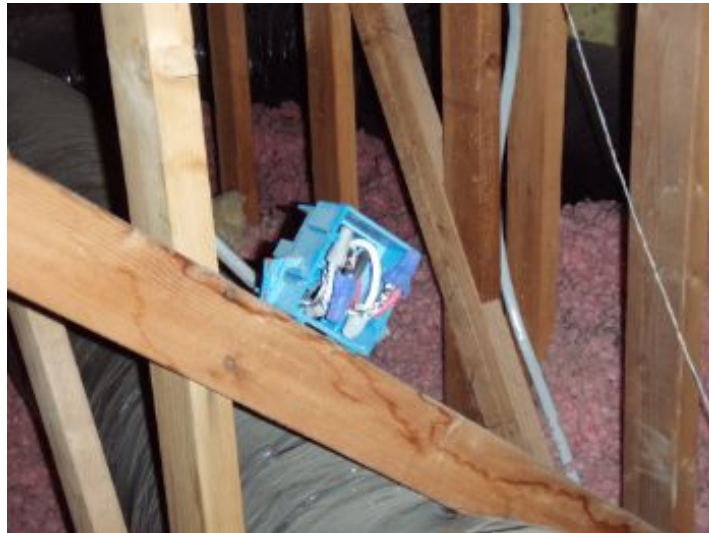
- Electrical Box Covers missing or damaged, which is a potential shock or electrocution hazard.
- Missing cover plates observed, suggest installing for safety.

Missing cover plate.

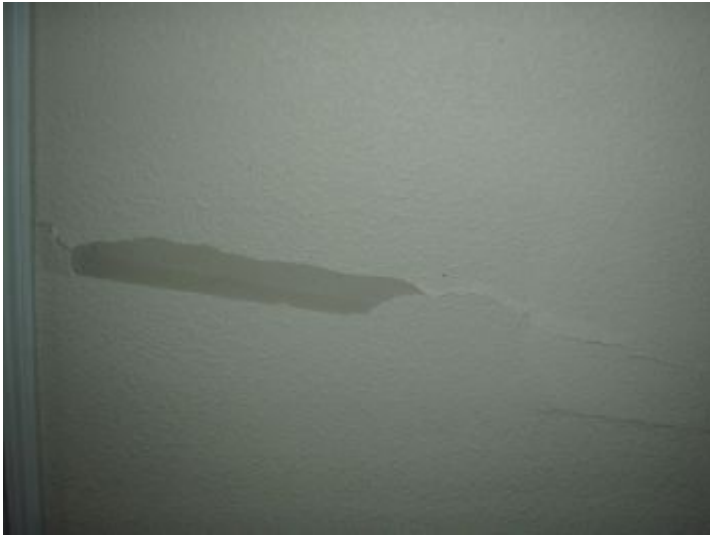
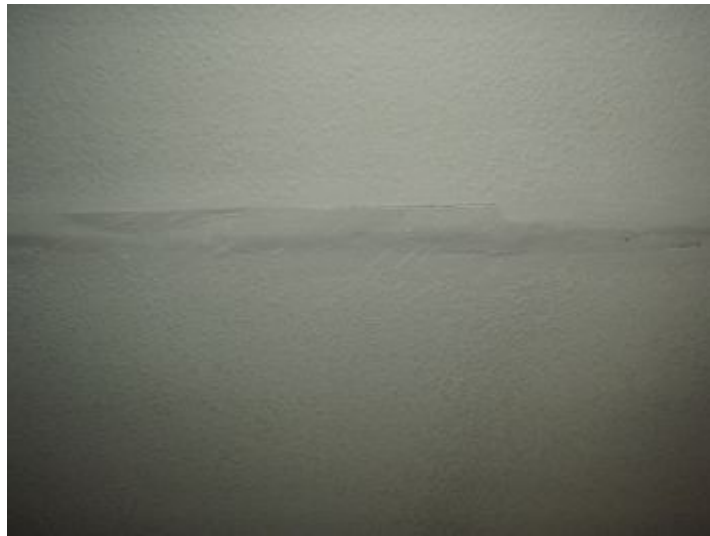
Observations:  
 • Personal items in garage block complete inspection of all floor, wall and ceiling areas.  
 • Garage drywall ceiling needs to be properly repaired.  
 • Hatch covering access to attic from garage is not fire-rated.

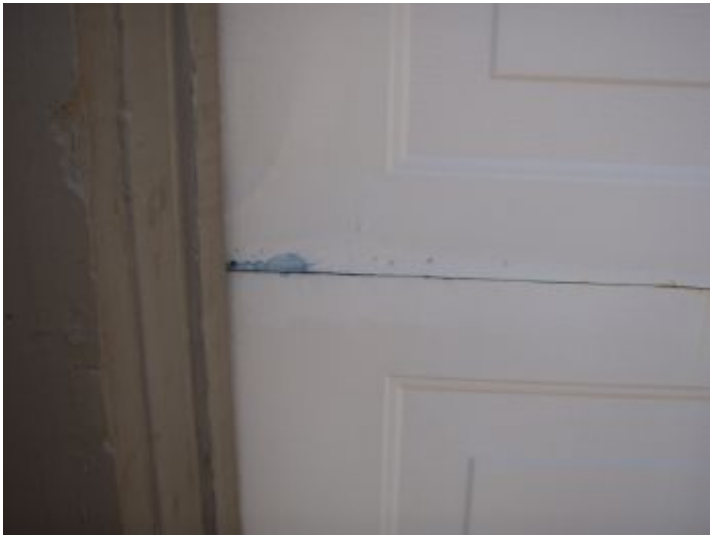
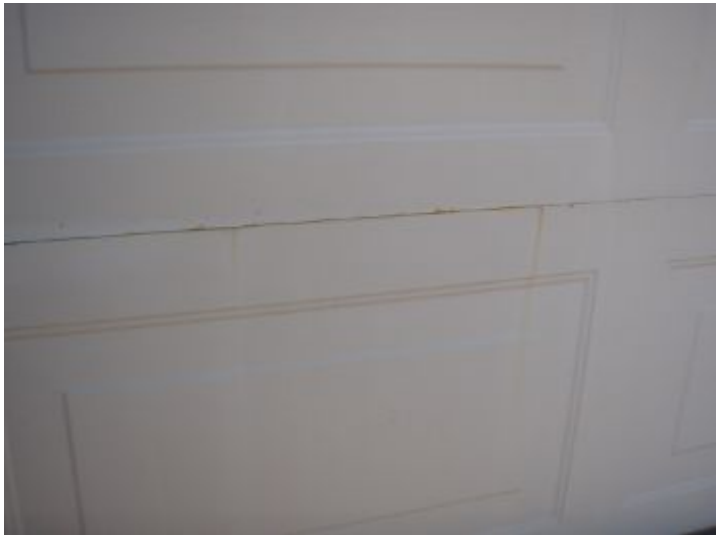
- Paint is peeling recommend repainting.
- Auto-Reverse worked when tested.
- Automatic opener worked when tested.
- Laser eyes, or sensor worked when tested.
- Garage door appears to have been painted in spots and rust stain was noted.

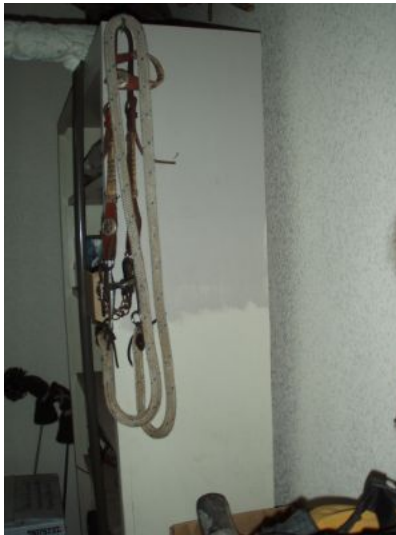
- Cabinets appeared functional and in satisfactory condition, at time of inspection.
- Shelving does not appear to be secured to wall. Recommend securing for increased safety.

After looking behind shelf it does not appear to be secured to the wall.

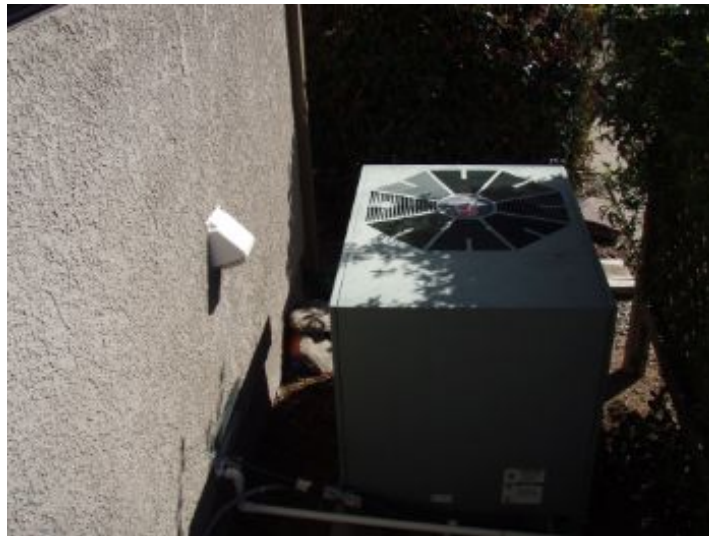
**Clothes dry exhaust vent is near AC Compressor. Recommend checking compressor regularly for build up on lint on compressor fins.**

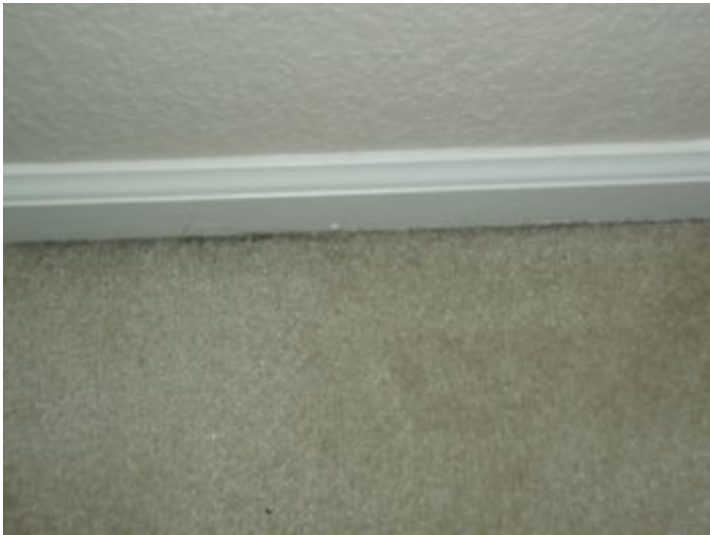
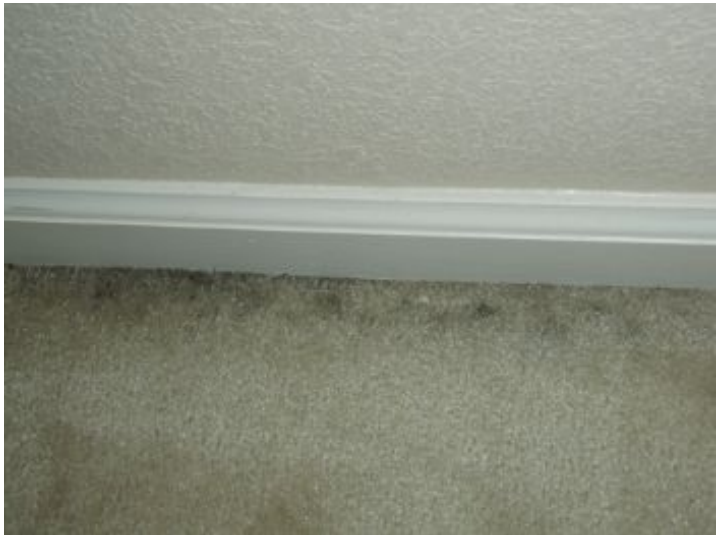
- Noted mold like growth in carpet along exterior wall.
- Recommend review by a qualified professional for repair or replacement.

Mold like growth.

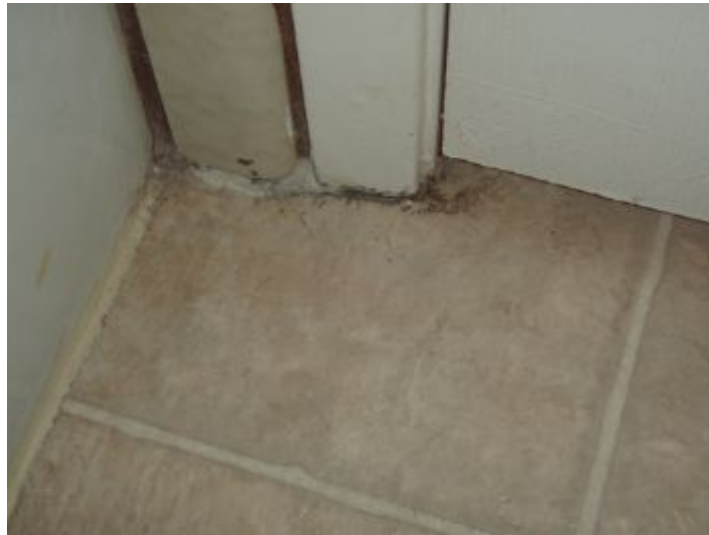
Materials: Vinyl floor noted.  
 Observations:  
 • Biological growth noticed at corner of shower and door.

Mold like growth between tub and door.

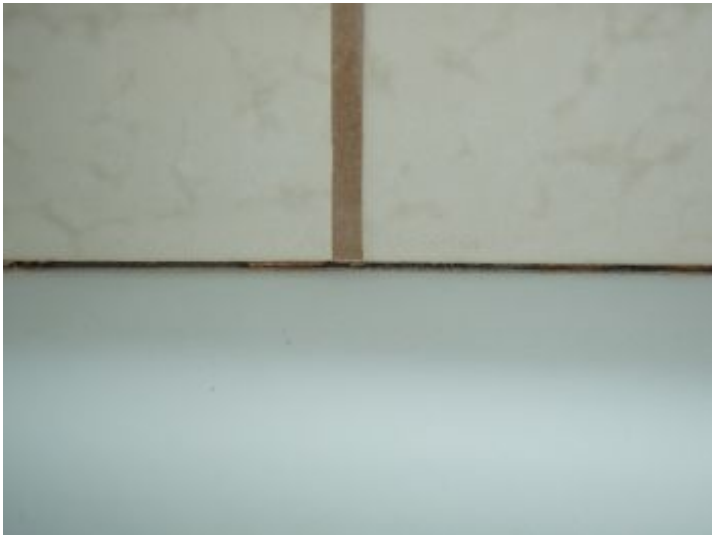
- Faucet appeared to be in good working order at time of inspection.
- Doors appeared to be in good working order at time of inspection.
- Hot/cold reversed plumbing observed.
- Grout missing between shower wall tile and tub. Recommend repairing to prevent water damage.

Missing grout.

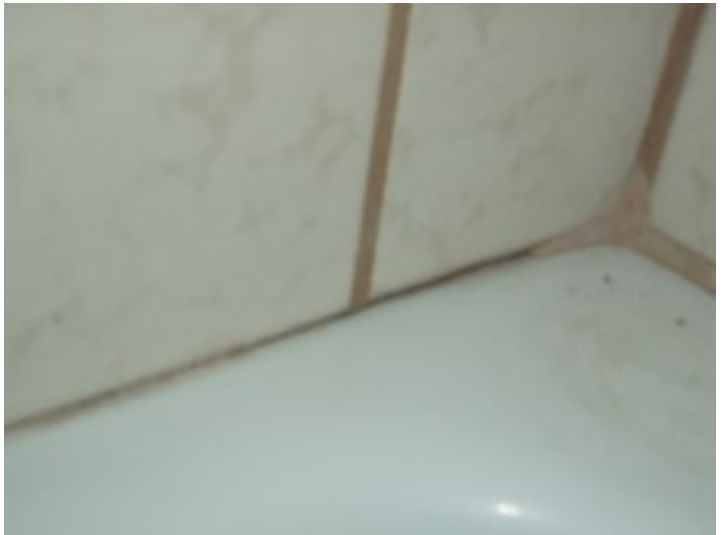
Missing grout.
